Connecting Tecopa: Bicycle and Pedestrian Safety Corridor Barriers, Improvements and New Routes/Facilities

Connecting Tecopa: Bicycle and Pedestrian Safety Corridor Tecopa Hot Springs - Barriers, Improvements and New Routes/Facilities

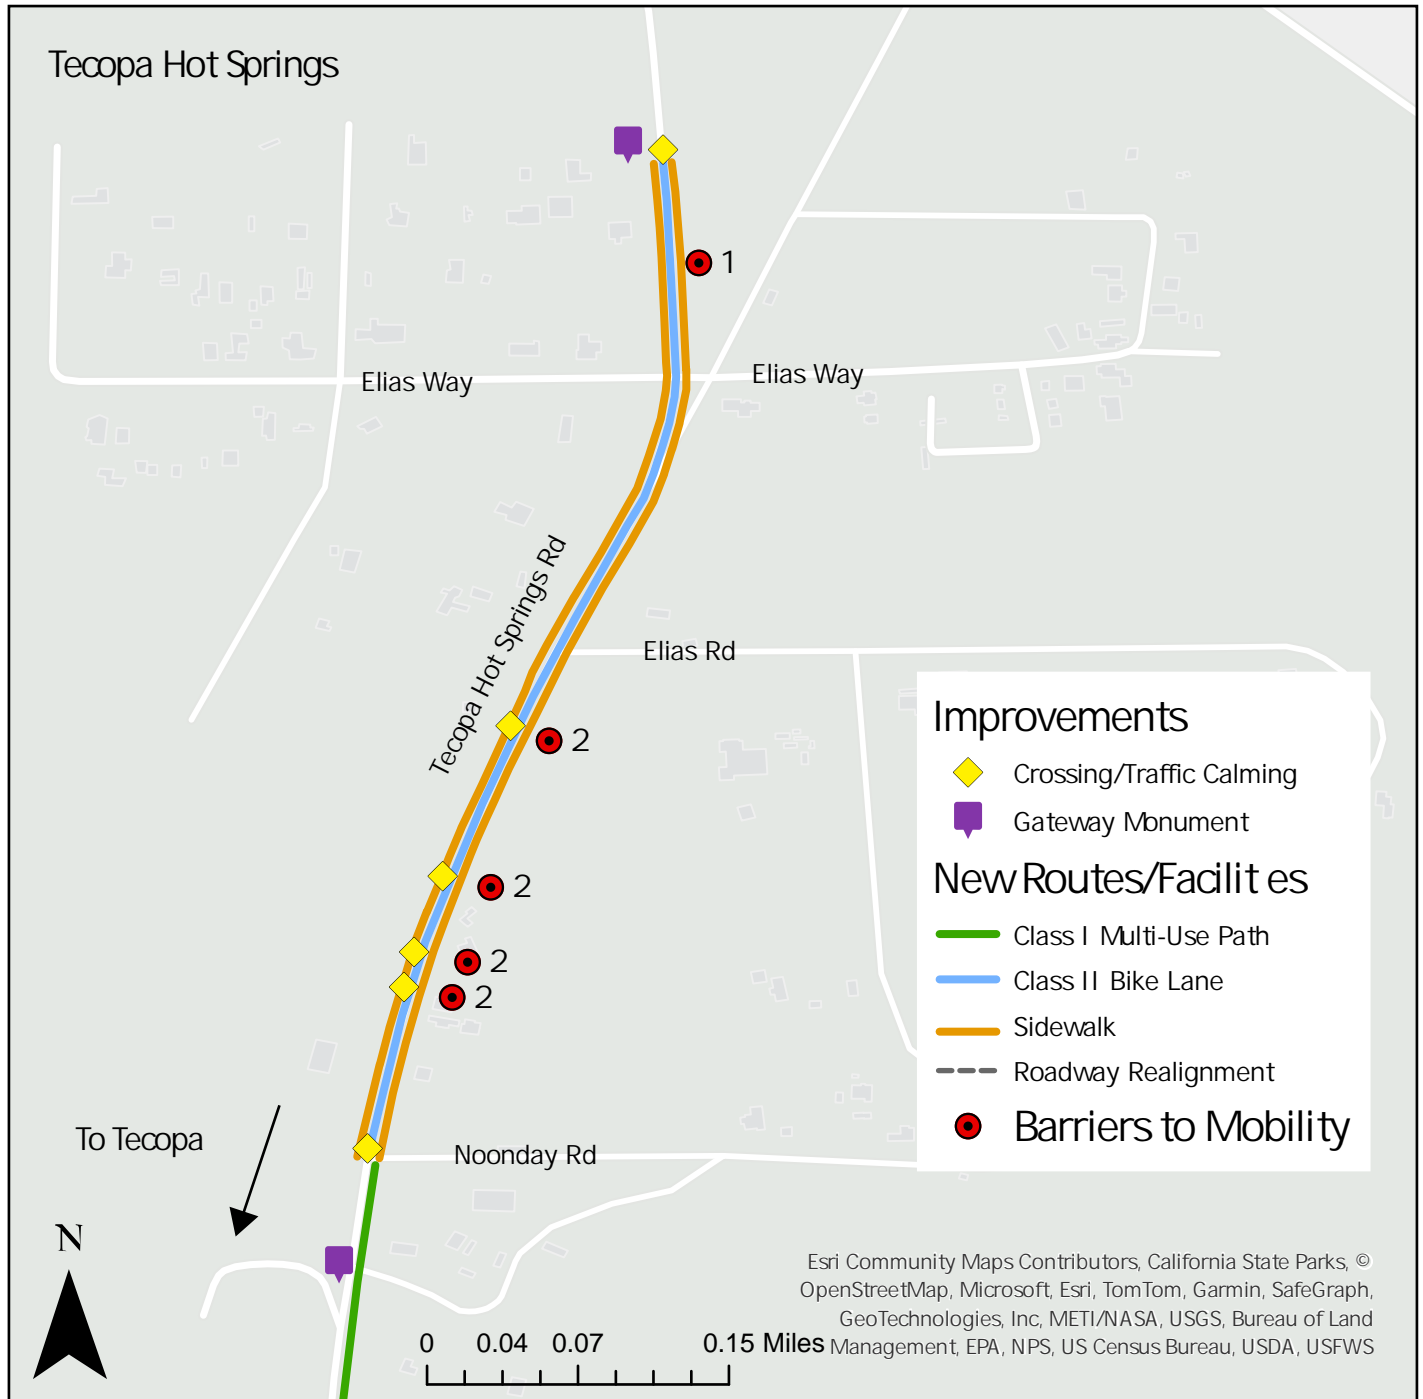
Barriers to Mobility:

- 1, Bike lanes end south of Tecopa Hot Springs. No bike/ped facilities in community center
- 2, Unsigned existing crosswalk provides inadequate safety for pedestrians
- 3, Inadequate separation from high-speed vehicles (55+ mph)
- 4, Short sight distance at Triangle, conflict with vehicles on roadway, no pedestrian crossings
- 5, No bike/ped facilities in community center
- 6, Conflict between bikes/peds and vehicles on roadway

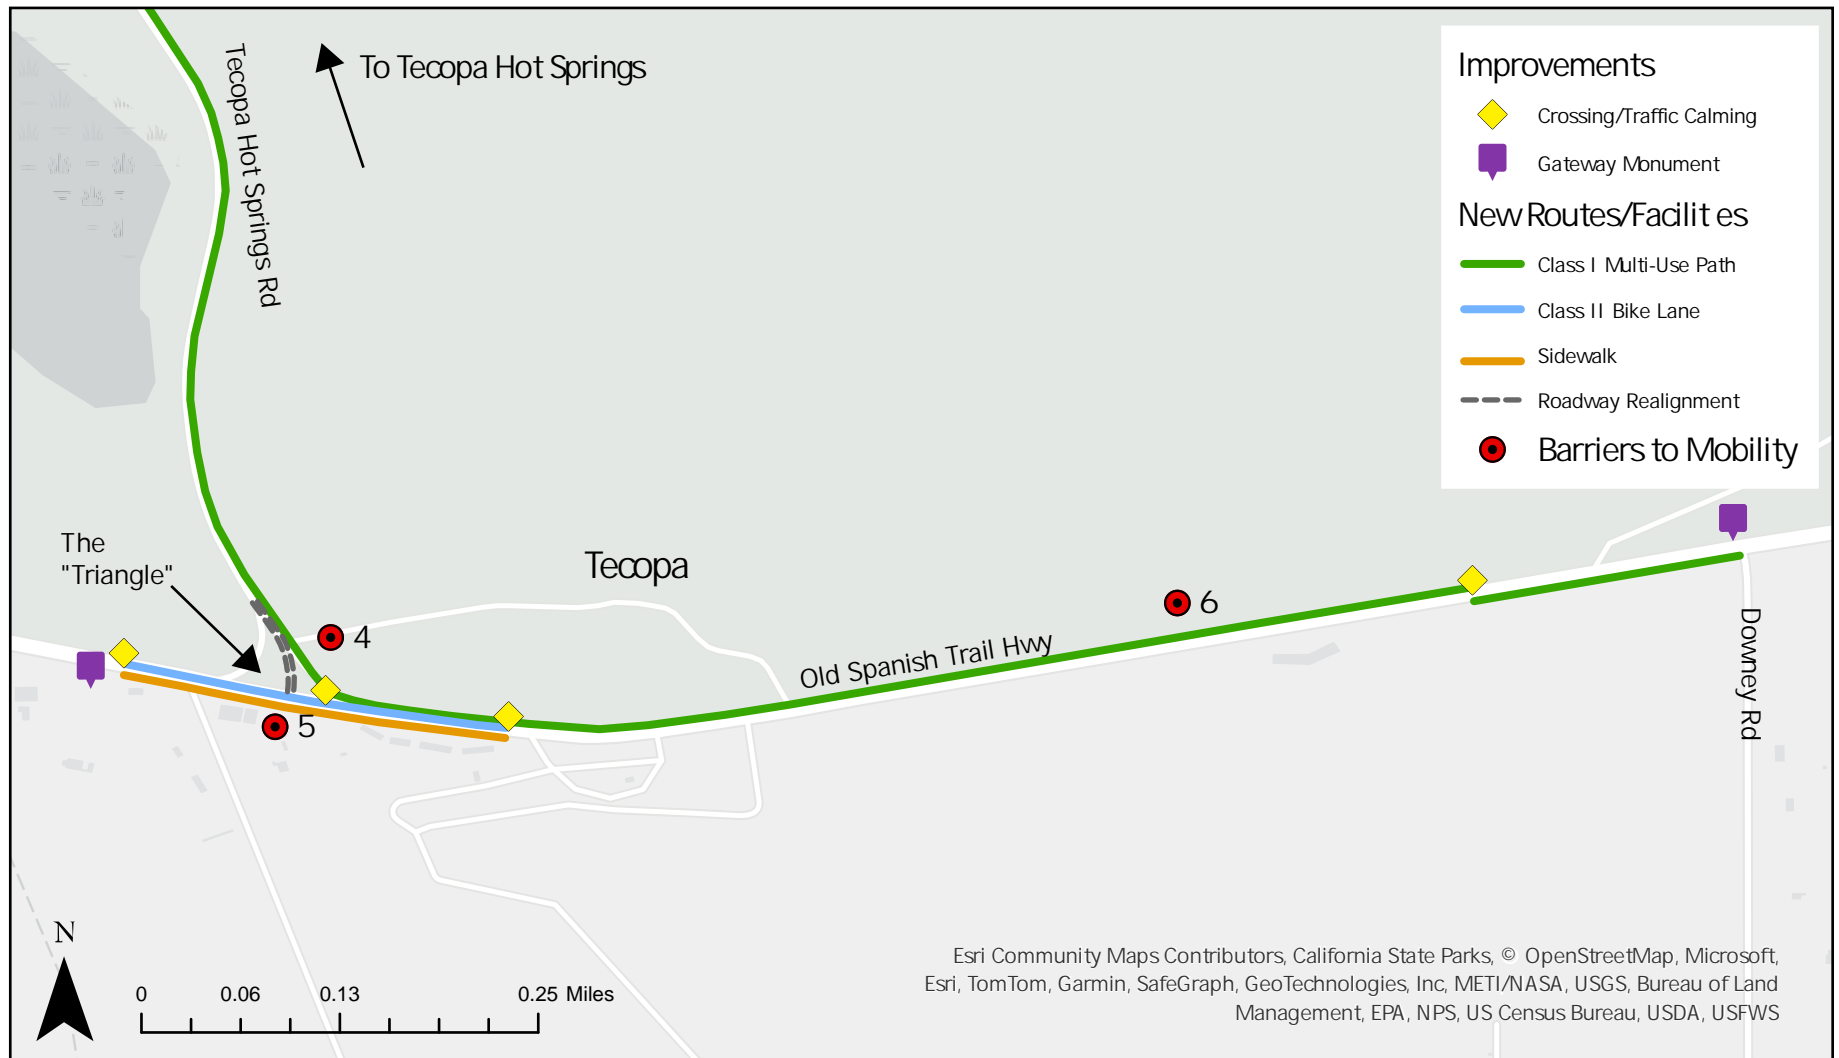
Connecting Tecopa: Bicycle and Pedestrian Safety Corridor Tecopa Hot Springs - Barriers, Improvements and New Routes/Facilities

Barriers to Mobility:

- 1, Bike lanes end south of Tecopa Hot Springs. No bike/ped facilities in community center
- 2, Unsigned existing crosswalk provides inadequate safety for pedestrians
- 3, Inadequate separation from high-speed vehicles (55+ mph)
- 4, Short sight distance at Triangle, conflict with vehicles on roadway, no pedestrian crossings
- 5, No bike/ped facilities in community center
- 6, Conflict between bikes/peds and vehicles on roadway
