**SUBJECT:** Minor Amendment to Conditional Use Permit (CUP) 1978-09 and Reclamation Plan 78-02 (Twin Mountain Rock Venture / Red Hill Quarry)

# **EXECUTIVE SUMMARY**

Twin Mountain Rock Venture L.L.C. (TMRV) is submitting an application for a revision to an existing approved Mining Reclamation Plan (Conditional Use Permit - CUP 78-9) for the Red Hill Quarry (CA Mine ID No. 91-14-0002). Red Hill Quarry is owned in its entirety by Angelus Block Company since 2015 and TMRV is the mine operator. The proposed revised Mining Reclamation Plan (Plan) will include updating the current plans, completing mining in the Main Quarry and extending mining to the northeast away from US 395 in order to utilize the on-site cinder reserves. The existing and proposed mining activities are and will be undertaken on its privately-owned property of approximately 297 acres; patented in the years 2000 and 2007. The Plan will include updated reclamation methods per the California Surface Mining and Reclamation Act (SMARA) implemented by the County of Inyo (County) within County Code Chapter 7.70 Surface Mining and Land Reclamation.

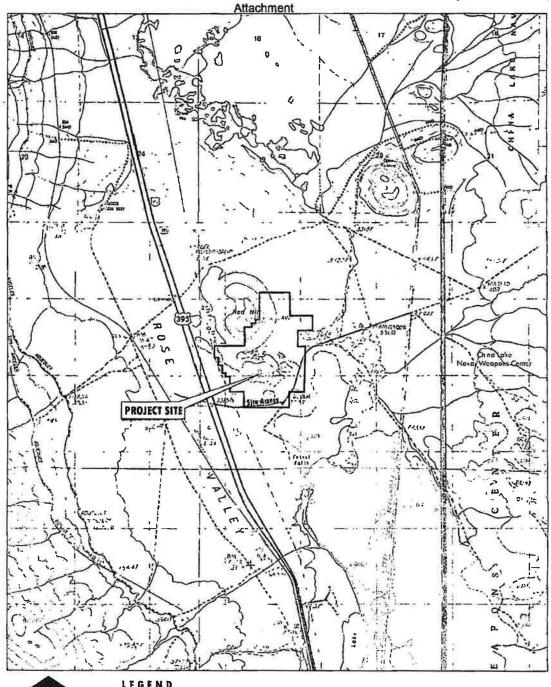
FIGURE 1

Red Hill Cinder Mine County of Inyo, CA

Red Hill Quarry is located approximately 12 miles south of Olancha on the east side of US 395 in Inyo County, California (see Figure 1 - Regional Location Map). The mine is within Sections 30 and 31, Township 22S North, Range 38E, Mount Diablo Meridian. The site is accessed from US 395, east onto Cinder Road approximately one mile to the mine site gate on the east side of the site (see Figure 2 - Vicinity Map). Red Hill Quarry produces red and black cinder rock and sands crushed and screened to various sizes, densities, and colors depending on product demand. The sized cinder materials are mostly trucked to its Angelus Block facilities in southern California as a component of cinder blocks used for construction. In addition, materials are used for landscaping, soil amendment, de-icing of roads, and other uses. Production has averaged around 55,000 tons per year and is increasing.

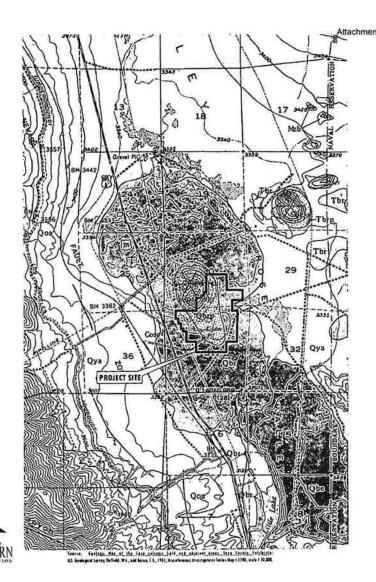
#### LEGEND

BASALT OF RED HILL - Moderately porphyritic basalt containing plagioclase, olivine, and clinopyroxene phenocrysts; xenoliths of granitic rocks common locally. Divided into two parts:

The mine utilizes cinder-size material emplaced as cone-erupted deposits from nearby Red Hill that overlay basalt flows of pahoehoe- and aa-type lavas. Cinders vary from black to red color and are sourced from localized eruption centers that changed location during emplacement activity. Native soils of light brown silty sandy alluvium overlie areas around the margin of the cinder deposits. Granitic basement rock underlies the volcanic pile. The cinders are very rough, angular clasts of abrasive siliceous rock material and are strongly interlocked by rough and angular contact. In cut slopes cinders stand at steep angles and exhibit planar joints that penetrate to depths up to 30 feet from native surface. Joints are locally filled with whitish caliche material. Cinders are not welded as in some volcanic piles and can be separated easily with a rock hammer; however, the material exhibits an effective cohesion from the rough and interlocked clast contacts.

Bedding planes exposed in limited cut slopes within the main pit area were measured to dip northward and eastward at angles of 50 to 60 degrees and 20 degrees, respectively. East dipping bedding was measured on a formerly-buried lava flow resting in contact with a cone flank. Bedding can be anticipated to vary throughout the site as construction of a volcanic pile is a somewhat random process that includes liquid material flow and air-fall actions. A northeast striking, steeply dipping joint set dominated the structure of the north highwall area. A 70-degree southward dipping joint system was also noted. The cinder material is anticipated to exhibit relatively homogeneous materials properties at the proposed 1H:1V cut slope angle.
